Case Studies of Landslide Stabilization with Deep Foundation Elements

Sebastian Lobo-Guerrero, Ph.D., P.E.

ABSTRACT: Slope stabilization with deep foundations is not widely used due to a lack of published design procedures. This article illustrates 2 case studies involving the installation of vertical micropiles and drilled shafts to stabilize significant mass movements. The first case study describes the stabilization of an ancient landslide (in soil) by using a total of 75 drilled shafts embedded into bedrock. The second case study describes the emergency stabilization of a rockslide with more than 110 uncased micropiles. The article presents the encountered geotechnical conditions, design aspects (global stability, p-y analyses, required embedment for passive resistance, group effects, structural capacity, etc.), and construction observations. These 2 cases are compared since the principles of design are completely different. For the rockslide stabilized with micropiles, the controlling failure criterion was shear at a defined joint system, while for the soil landslide flexural stresses on the drilled shafts controlled the design. The proposed design methodologies depending on

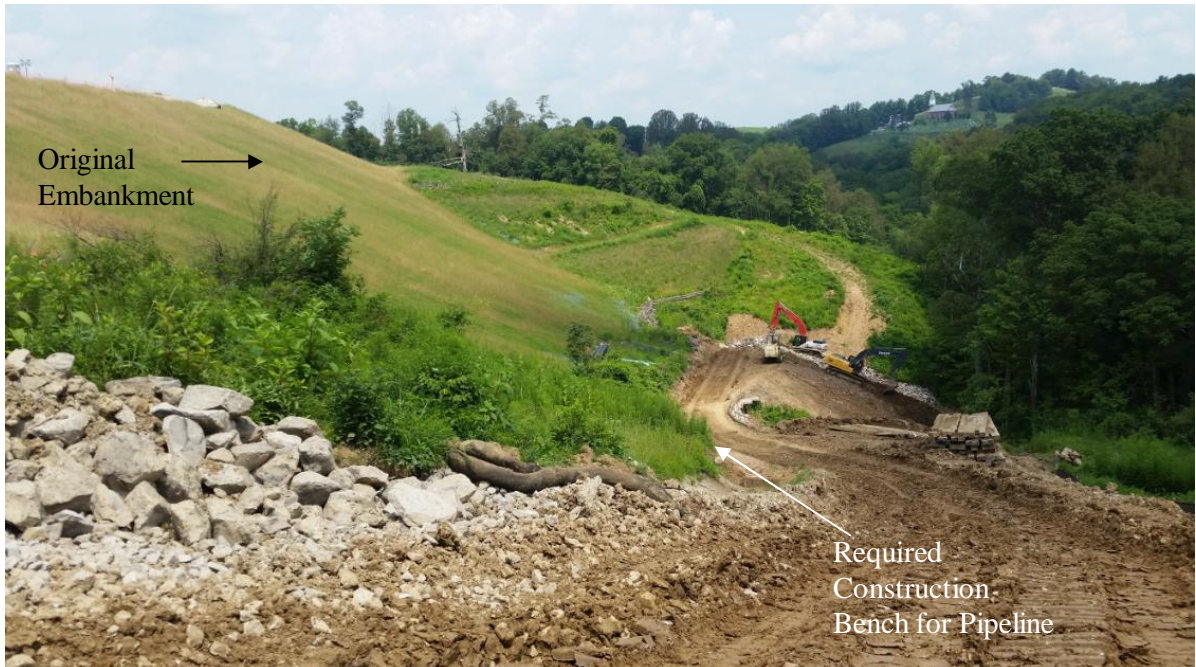
pipeline in addition to a 50 ft (15.2 m) wide bench for construction access near the existing toe. To accommodate the bench width, an additional 45 ft (13.7 m) tall embankment below the existing 110 ft (33.5 m) tall embankment needed to be constructed. The upper 110 feet existing embankment had a 2H:1V slope while the proposed lower stabilized slope/embankment had a slope of 1.3H:1V. A preliminary design considered installing a rock embankment below the existing slope for the construction bench; however, the global stability FS was less than 1.5 (minimum allowed). Drilled shafts were proposed to resist and minimize disturbance to the existing soils. See Figure 1 for an overview of the site.

Figure 1. Overview of the site.

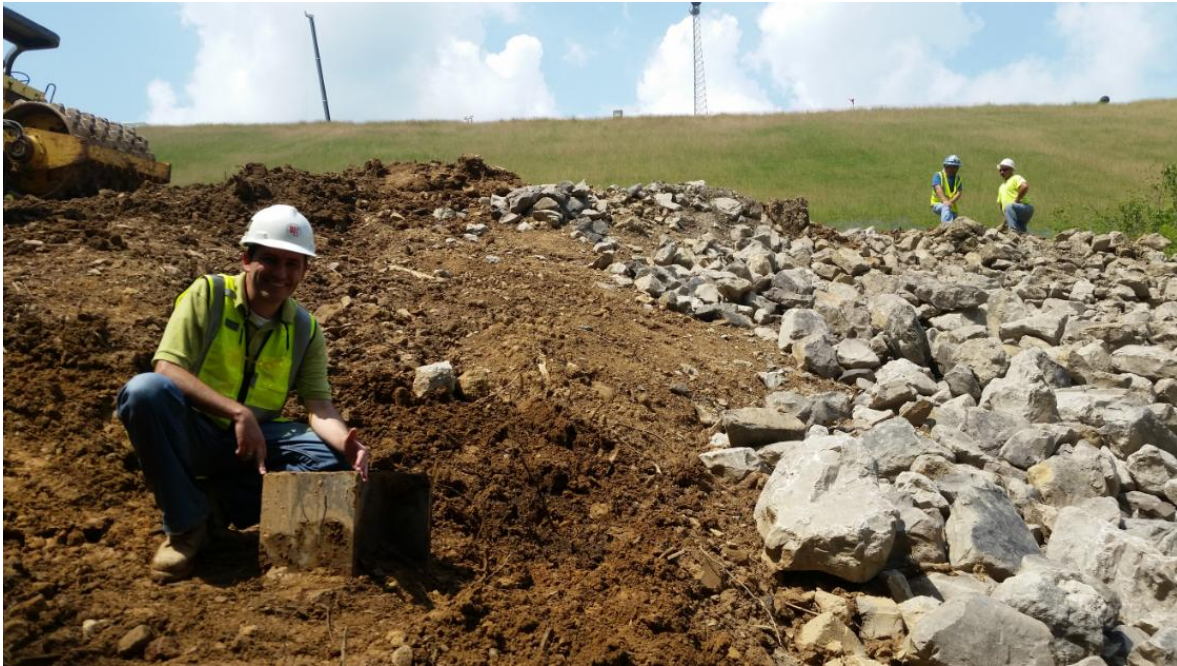
Reconstruction of the slope including the construction bench and installation of the pipeline was successfully completed within four weeks. No significant observations (i.e., tension cracks, differing subsurface conditions, etc.) were encountered during construction that required deviations from the proposed design. See Figures 3 and 4 for photographs during construction.

Figure 3. Terminated Drilled Shaft/Steel Section after Construction

Ultimately, the design mandated the installation of 75 drilled shafts (30 in [762 mm] in diameter and 40 ft [12.2 m] deep) in three rows along the embankment embedded into bedrock. The drilled shafts were constructed using vertically placed W18x106 (W460x158), 50 ksi (345 MPa) steel beams and concrete with a 28-day compressive strength of 3,000 psi (20.7 MPa). The drilled shafts were installed approximately 10 ft (3 m) into competent bedrock, resulting in an overall length between 30 and 40 ft (9.1 and 12.2 m).

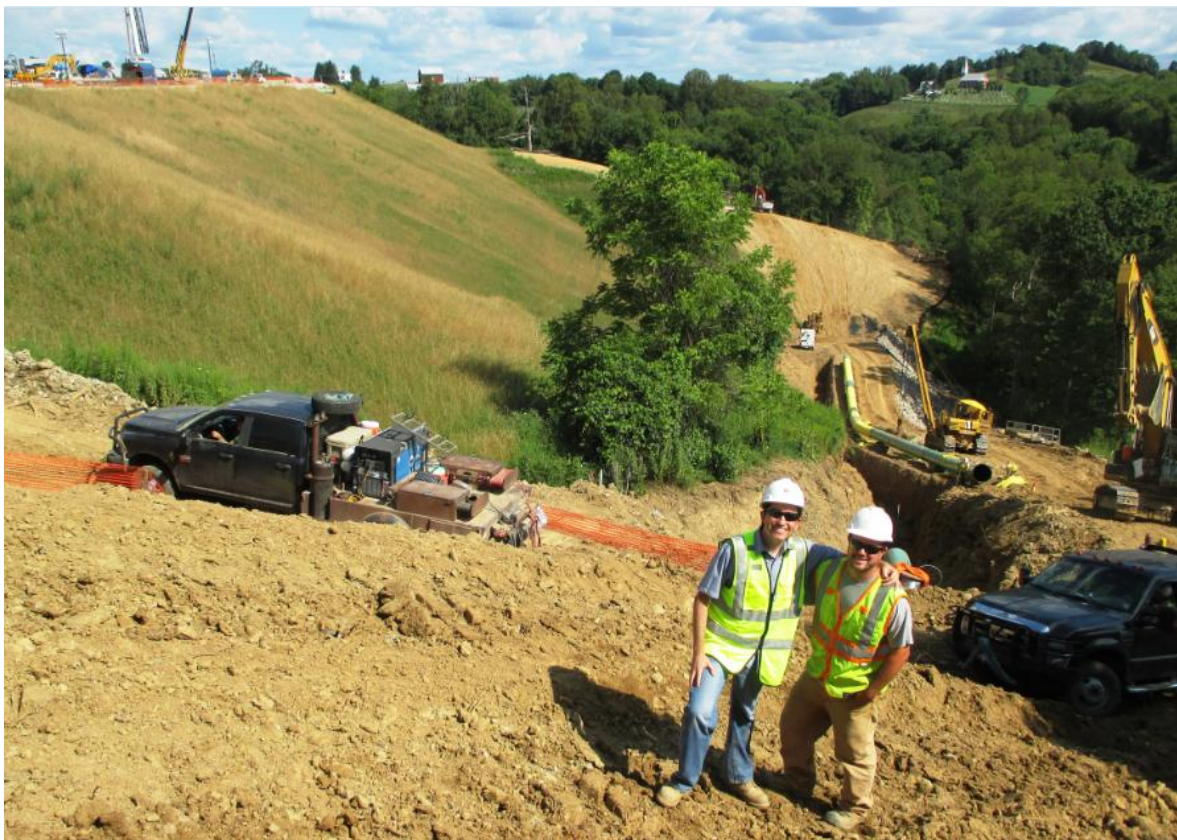
Figure 4. Pipeline Installation After Construction of the 75 Drilled Shafts

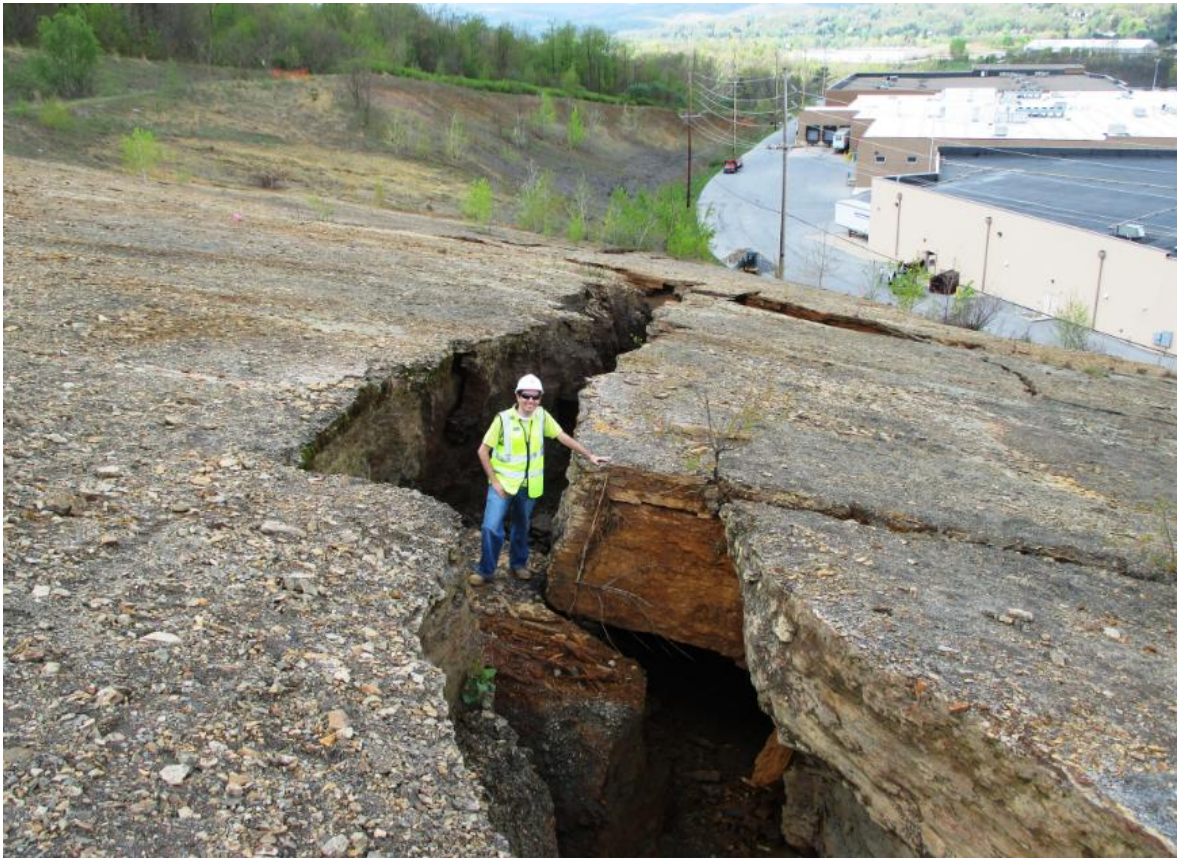
This case study considers a landslide in an existing rock cut located uphill from a shopping plaza in Pennsylvania (USA). The landslide created tension cracking along the existing rock cut, and during a period of weeks the tension cracks expanded from inches to feet (mm to meters). Survey readings indicated that portions of the slide were moving at a rate of approximately 2 in/day (5 cm/day). In addition to the shopping plaza, high voltage electric lines and an underground gas line ran along the base of the rock cut, further prioritizing the need to mitigate the failure as quickly as possible. See Figure 5 for a picture of the rockslide after initial movement.

Figure 5. Tension Crack at top of the Rockslide

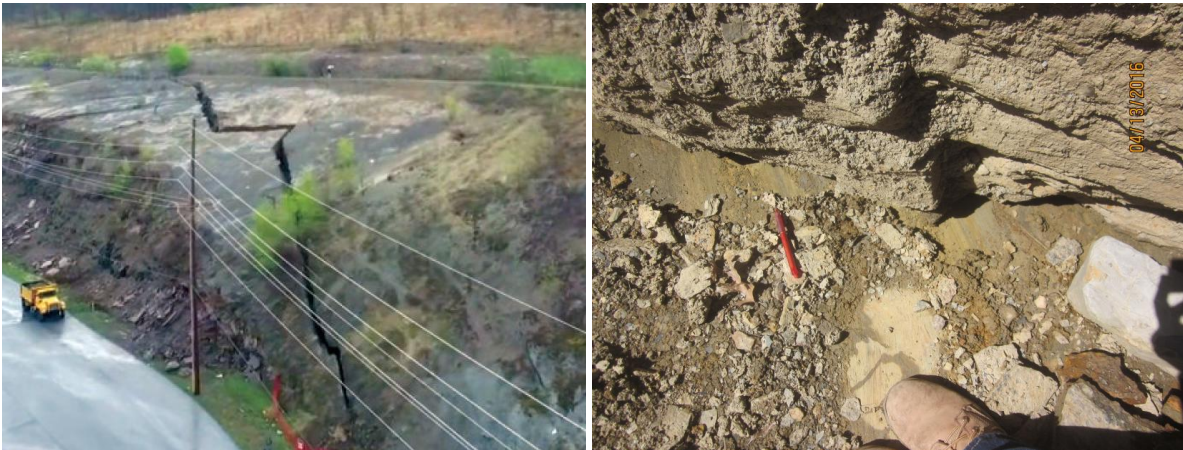
The site investigation revealed that bedrock along the cut consisted of sandstone with interbedded shale with a bedding dip of about 16 degrees. The orientation of the dip was downslope along and towards the cut. A drainage ditch was present upslope of the failure scarp, and was intended to divert water from wetlands upslope. Water flow within the ditch seemed to “disappear” in the region closer to the scarp. It was believed that surface runoff had been flowing into the slide rather than following the path of the constructed drainage ditch. Water could be heard flowing within the tension cracks of the slope failure, and seepage was observed along the slope. See Figure 6 for an overview of the rock slide, and a closer view of the failure plane.

Figure 6. Overview of the Rockslide and Closer View of the Failure Plane.

The mode of failure was due to weathering and degradation of thin shale layers within sandstone. These shale layers weathered over time due to groundwater infiltration, and produced a slide surface for the bedrock above. The size of the sliding mass (interbedded sandstone and shale block) was approximately 400 ft (122 m) wide by 150 ft (46 m) upslope by 20 ft (6 m) thick.

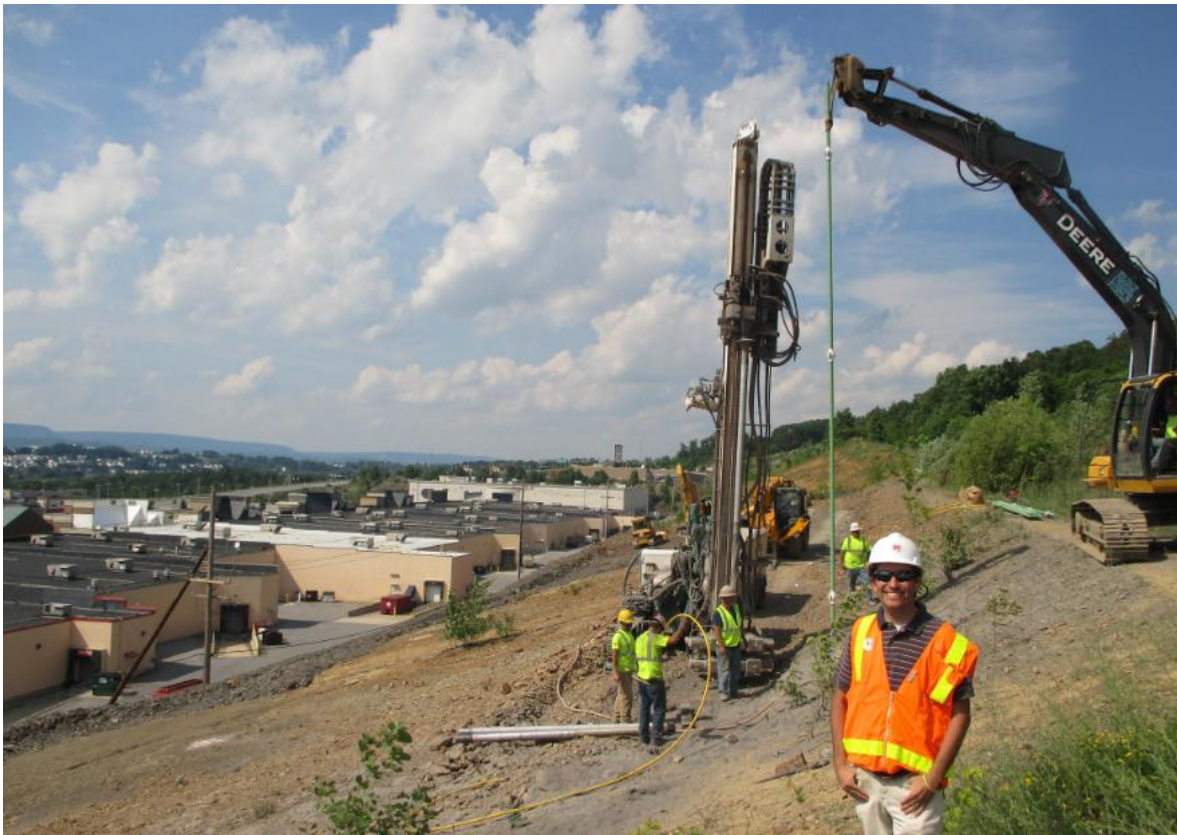
The three rows of shear pins were installed over a span of approximately three weeks without any significant inconvenience. Figure 8 shows the installation of the first micropile at the site.

Figure 8. Installation of First Micropile at the Site

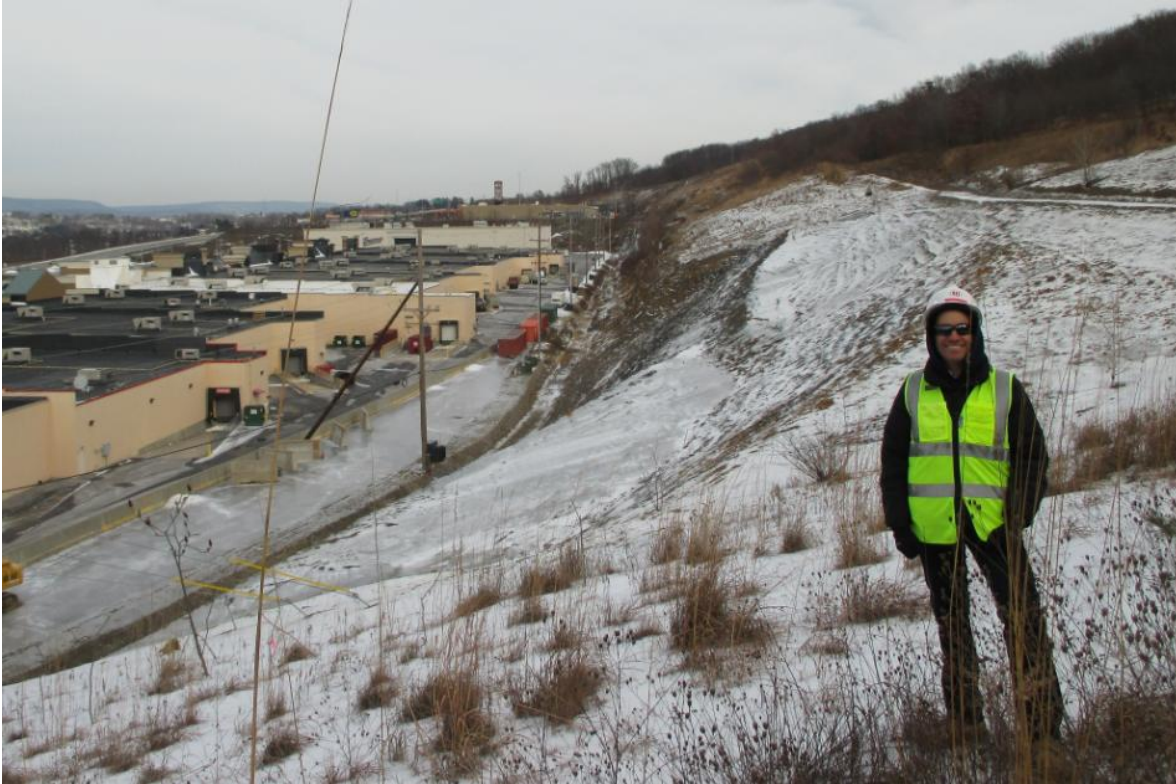
Once the 110 micropiles were installed, removal of the failed mass was completed and the upper channel was reconstructed. Figure 9 shows a view of the site after completion of the project.

Figure 9. Installation of First Micropile at the Site
